UNDERWATER BRIDGE INSPECTION REPORT

STRUCTURE NO. 7248

RED LAKE RIVER

DISTRICT 2 - PENNINGTON COUNTY

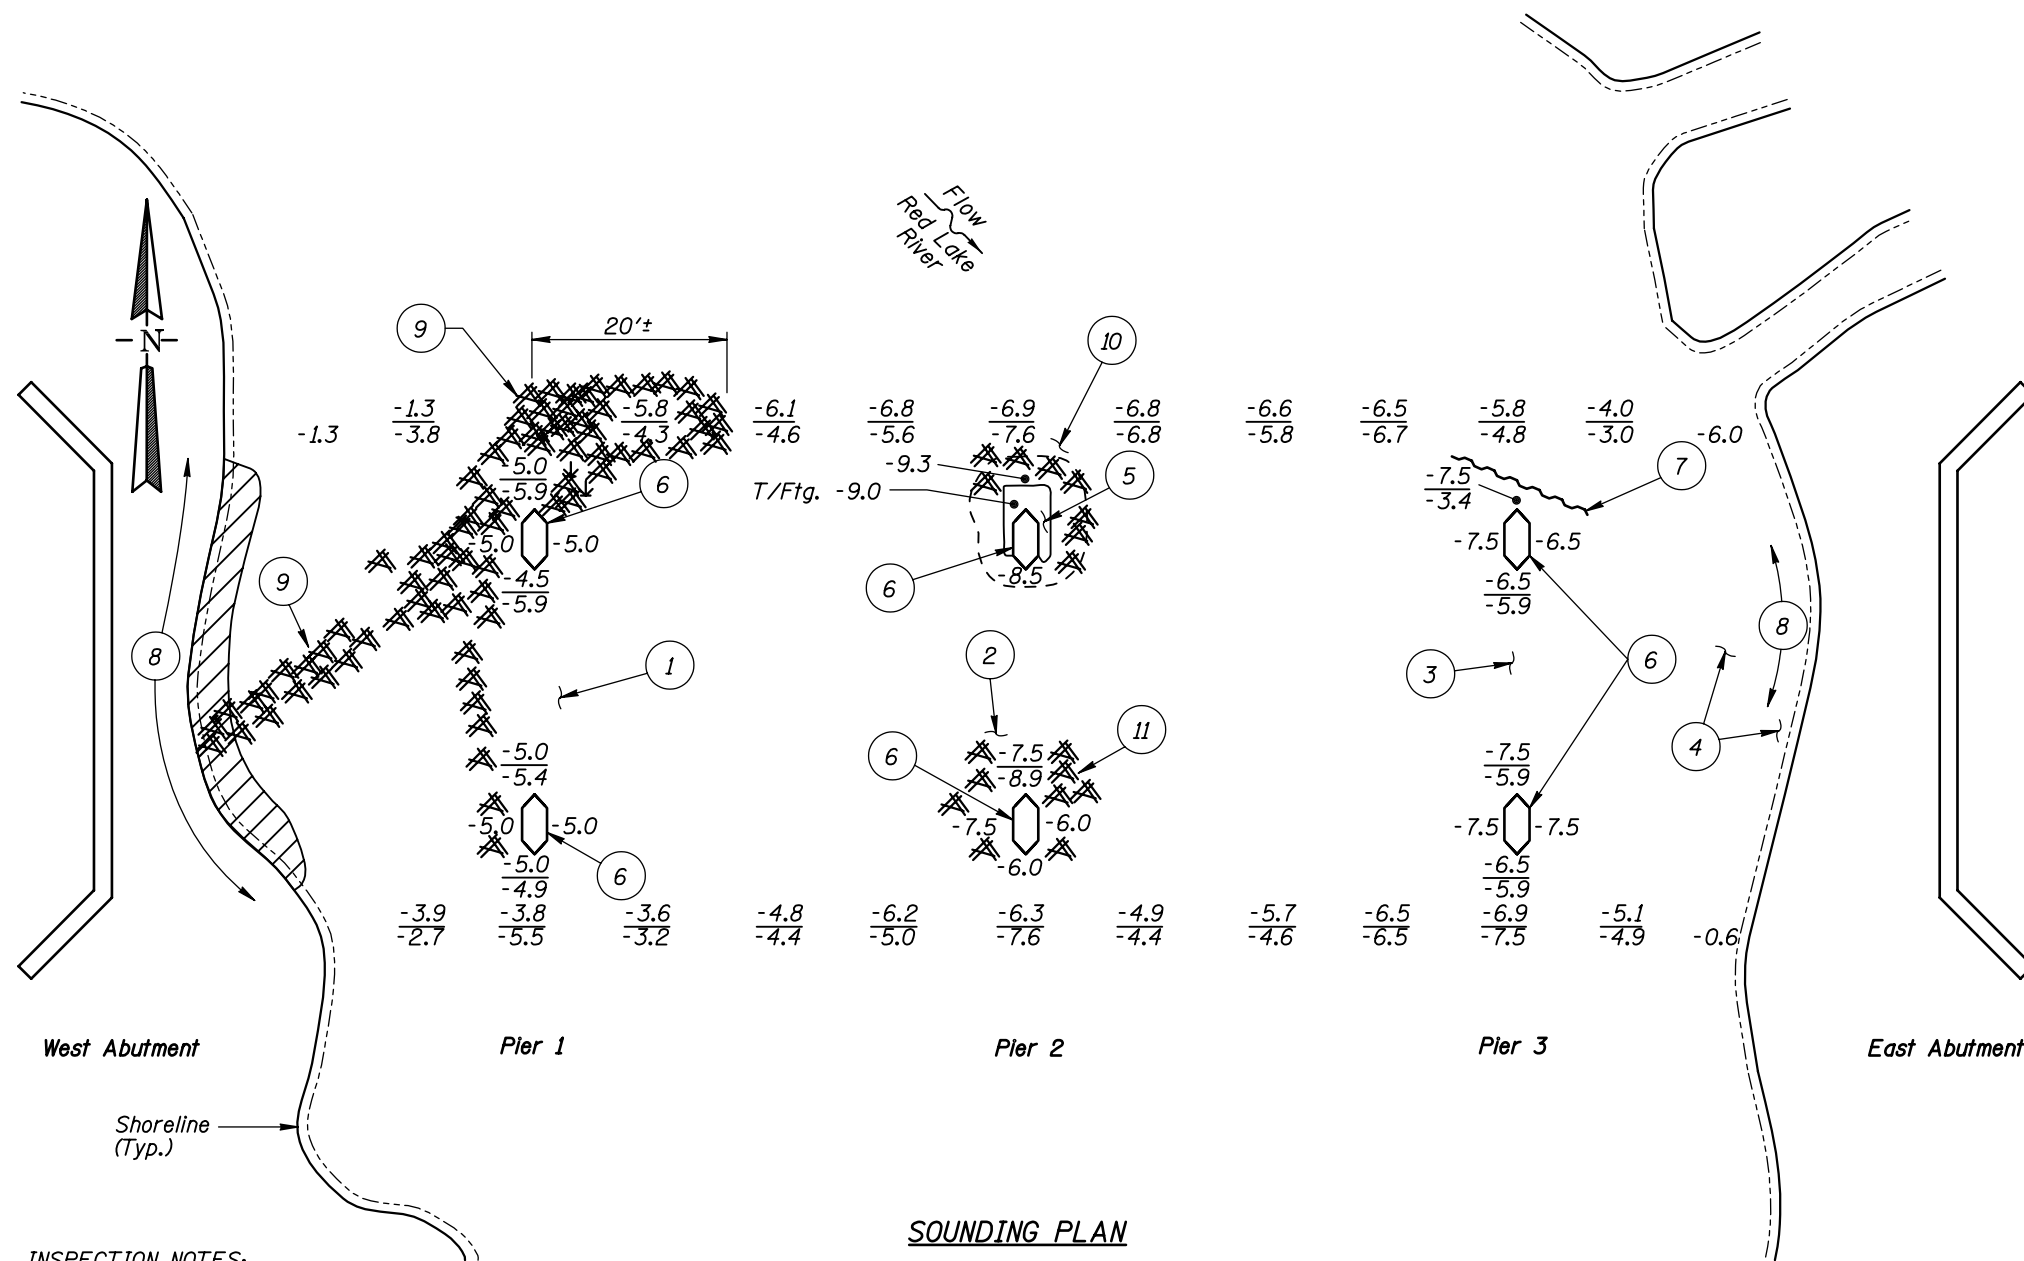
INSPECTION AND SOUNDING PLAN

Presence or absence of piles could not be determined.

| <p>1 The channel bottom material consisted of soft, silty infill with 1.5 to 2 feet of probe rod penetration around Pier 1.</p> <p>2 The channel bottom material consisted of sandy infill with 0.5 to 1 foot of probe rod penetration around Pier 2.</p> <p>3 The channel bottom material consisted of fairly firm sandy gravel with 3 to 6 inch diameter cobbles and a probe rod penetration of 3 to 6 inches around Pier 3.</p> <p>4 The channel bottom and shoreline of the east bank consisted of soft silty infill with 1.5 to 2 foot diameter riprap along the shoreline.</p> <p>5 A scour pocket, 2 to 3 feet in radius with a depth of 1 foot, was observed at the upstream nose of Pier 2. The scour pocket exposed the top of the footing around the column and 3 inches of the vertical face at the upstream end.</p> <p>6 Light scaling and random pop outs were observed around all columns from 2.5 feet to 3.5 feet below the waterline with 1/8 inch of maximum penetration.</p> | <p>7 Steel sheet piling was observed protruding from the channel bottom up 2 feet for a length of 10 feet.</p> <p>8 Erosion pockets have developed along both embankments since the previous inspection.</p> <p>9 A heavy accumulation of 2-foot-diameter and smaller timber debris was observed extending from the west shoreline to 20 feet east of Pier 1 and 15 feet upstream of the pier. The debris extended from the channel bottom to 5 feet above the waterline at the upstream column of the pier and from the channel bottom to 2 feet above the channel bottom along the shore side of the pier.</p> <p>10 A heavy accumulation of 1-foot-diameter and smaller timber debris was observed at the upstream column extending from the channel bottom to the waterline and 1 to 3 feet upstream of the column.</p> <p>11 A heavy accumulation of 1-foot-diameter and smaller timber debris was observed at the downstream column extending from the channel bottom to 3 feet above the waterline and 5 feet upstream of the column.</p> |

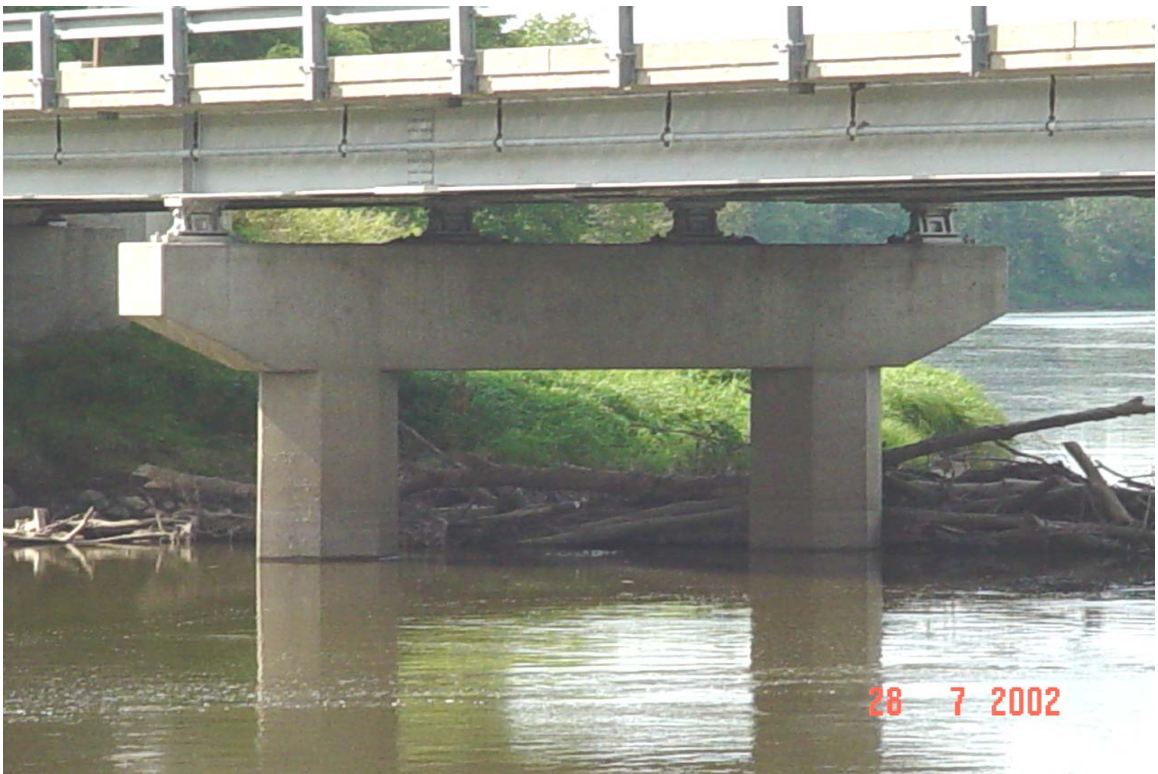
Photograph 2. View of Pier 1, Looking Northwest.

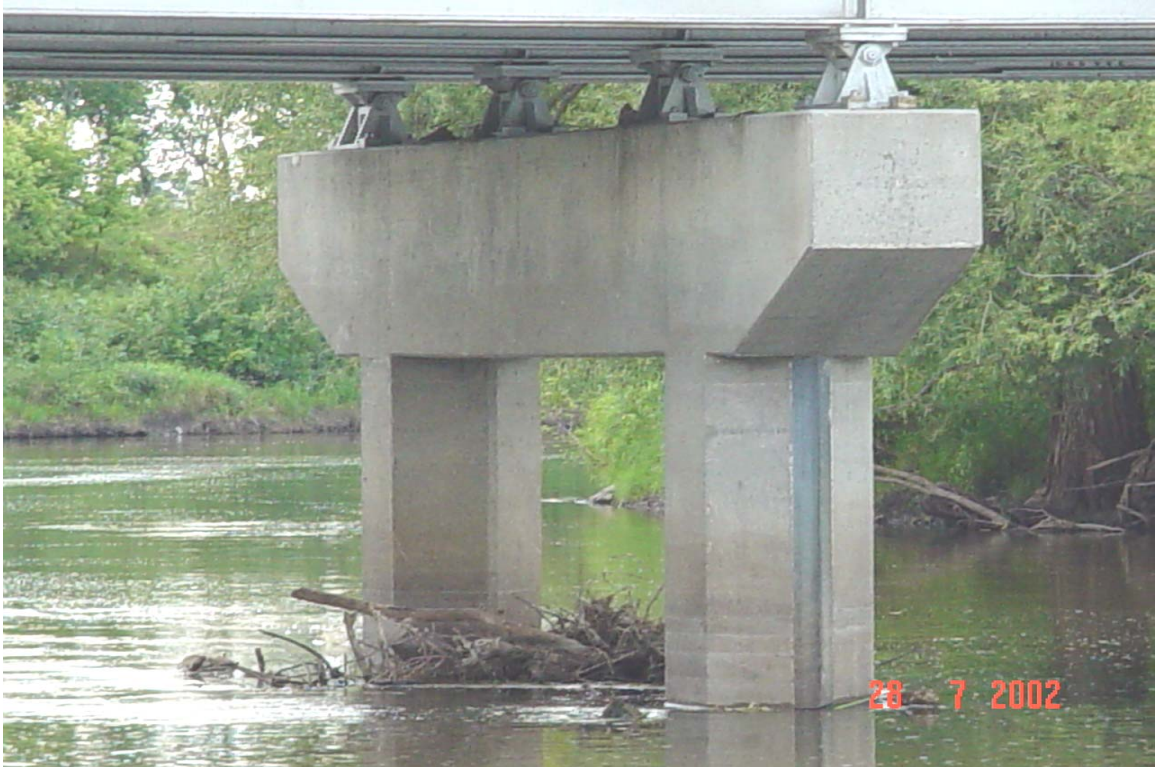
- (A) A scour pocket, 2 to 3 feet in radius with a depth of 1 foot, was observed at the upstream nose of Pier 2. The scour pocket exposed the top of the footing around the column and 3 inches of the vertical face at the upstream end.

Photograph 3. View of Pier 2, Looking Southwest.

Determine the significance of the footing exposure at Pier 2 by reviewing the design drawings to determine if the pier footings are founded on piles. If the columns are founded on piles, monitor the extent of footing exposure during future inspections. If the columns are founded on spread footings, then countermeasures may be required.

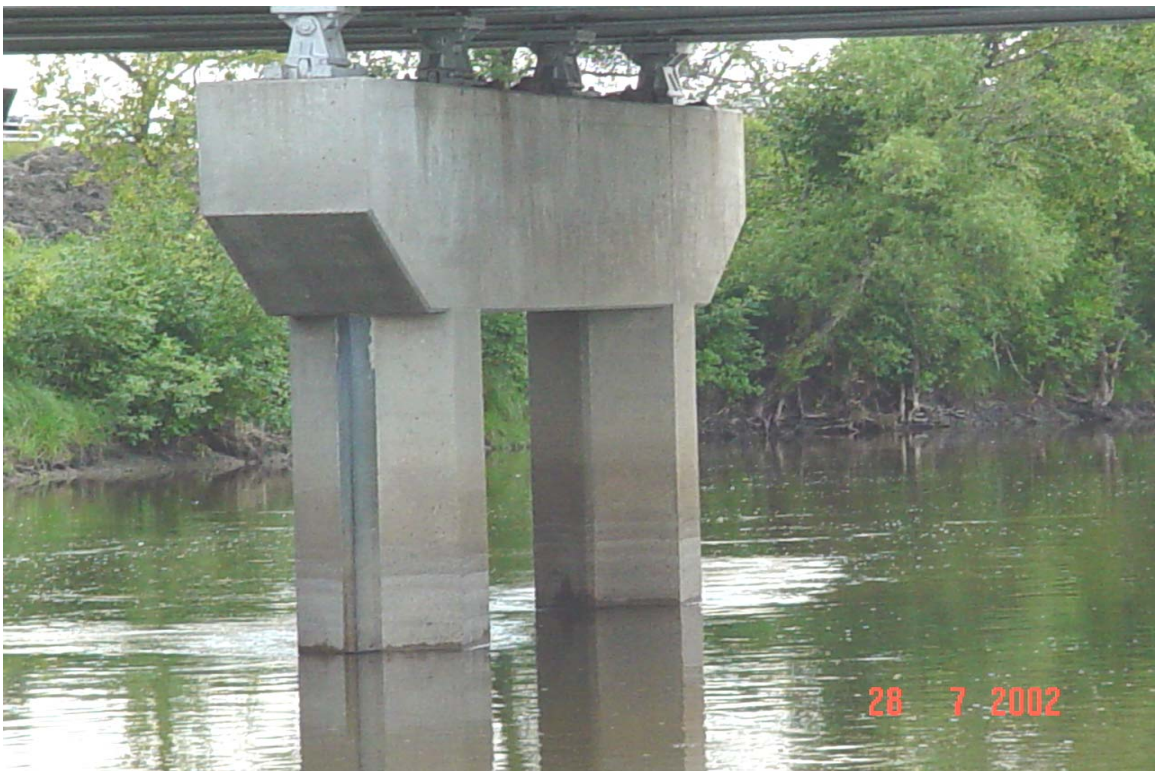
- (F) A 10 foot long section of steel sheet piling was observed protruding from the channel bottom up 1 foot at the north end of Pier 3.

Photograph 4. View of Pier 3, Looking South.

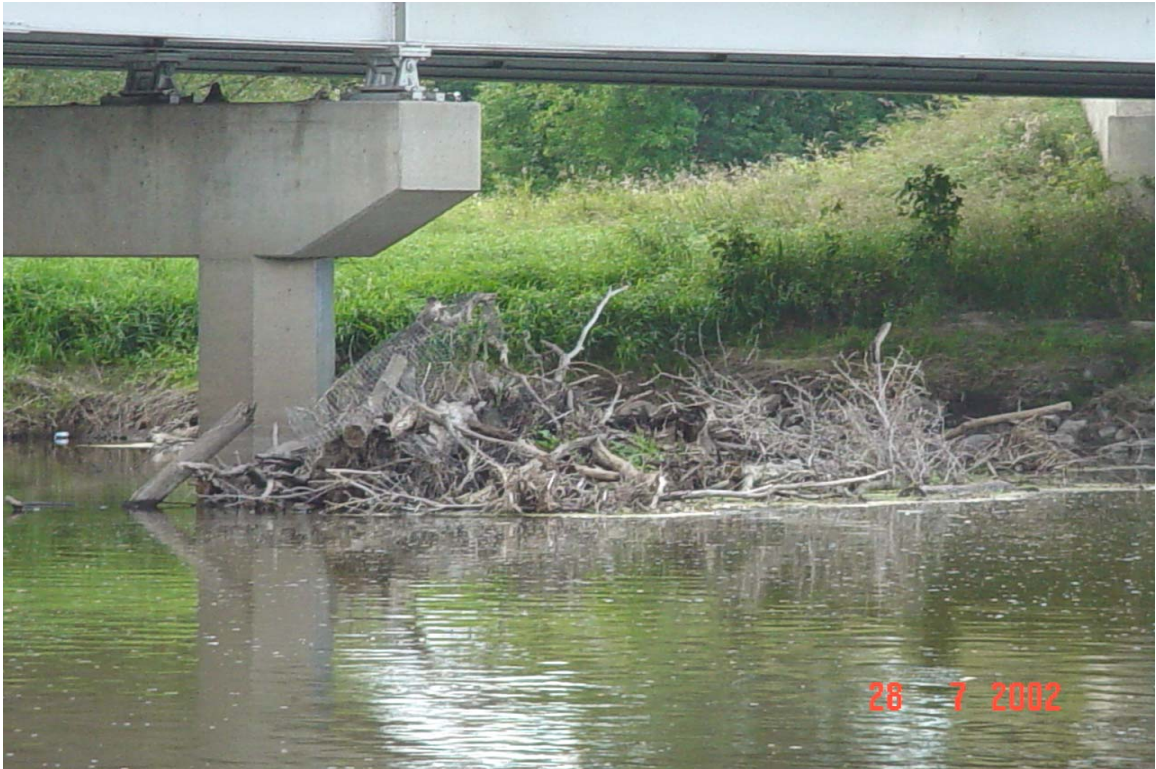
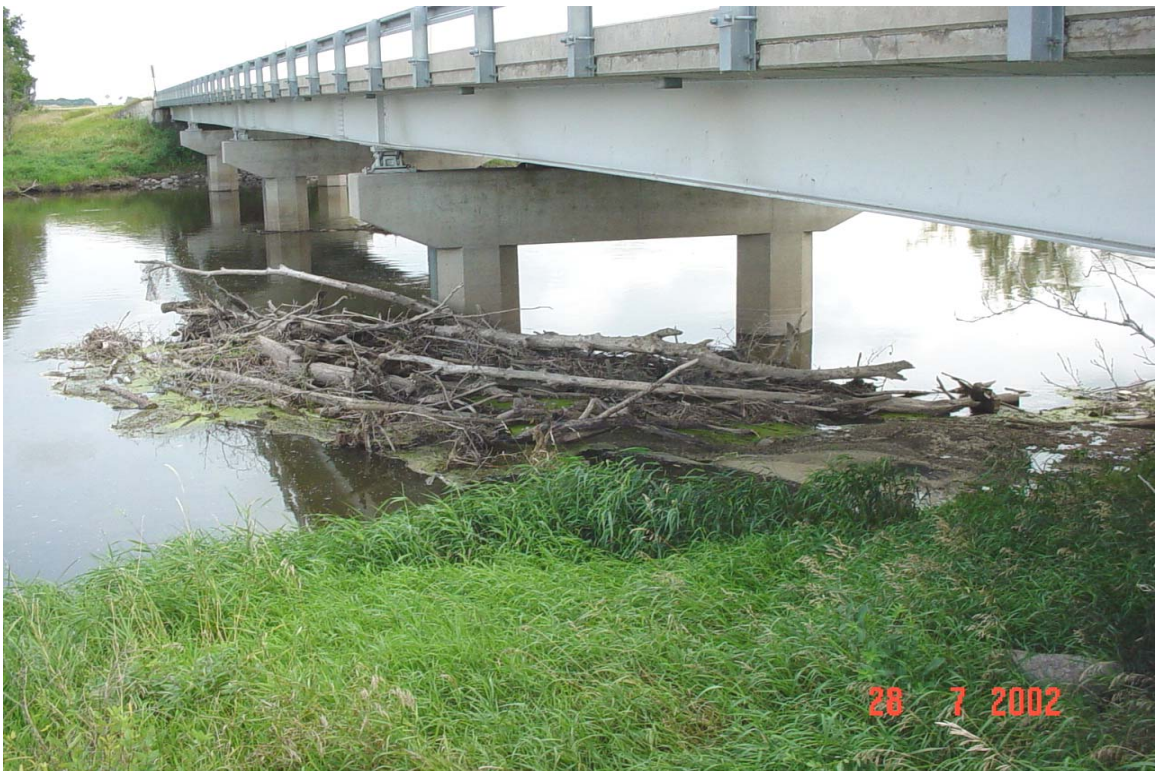
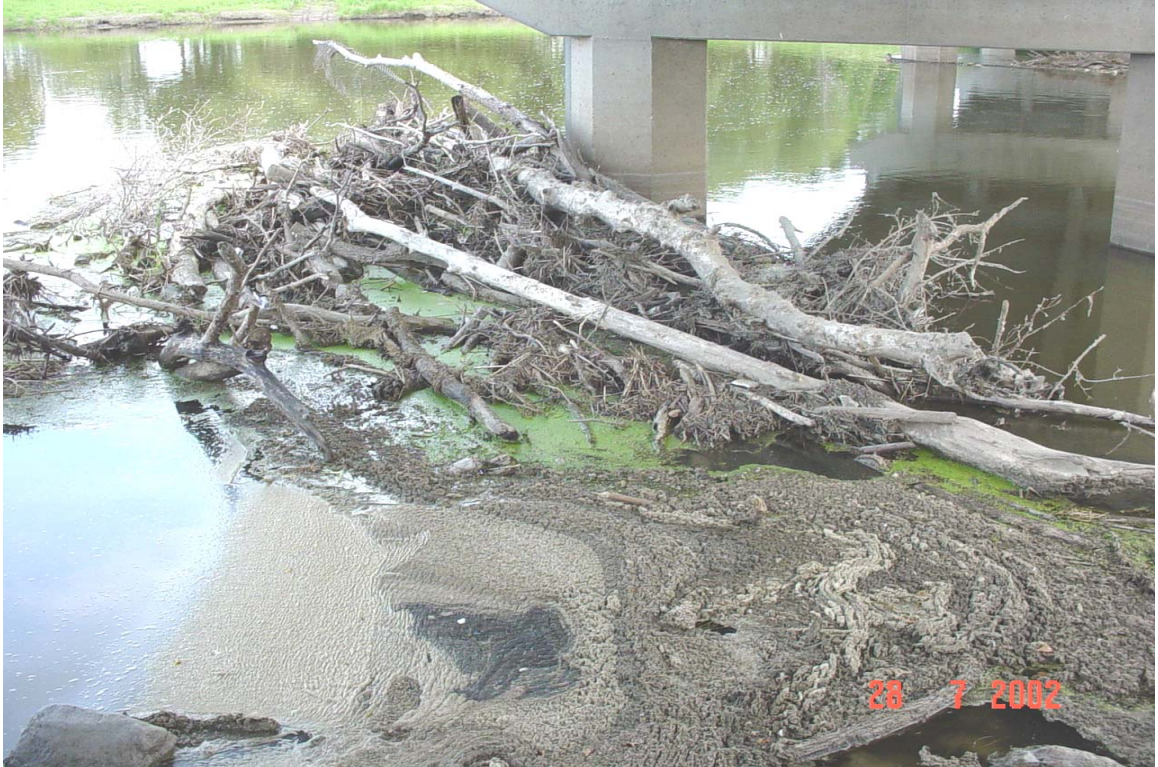
- (C) A heavy accumulation of 2 foot diameter and smaller timber debris was observed extending from the west shoreline to 20 feet east of Pier 1 and 15 feet upstream of the pier. The debris extended from the channel bottom to 5 feet above the waterline at the upstream column of the pier and from the channel bottom to 2 feet above the channel bottom along the shore side of the pier.

Photograph 5. View of Timber Debris at Pier 1, Looking Southwest.

Photograph 6. View of Timber Debris at Pier 1, Looking Southeast.

Photograph 7. View of Timber Debris at Pier 1, Looking Northeast.

Remove the heavy accumulation of timber at Piers 1 and 2 to eliminate the potential for continued accumulation and to halt any scour or erosion influenced by the accumulations.

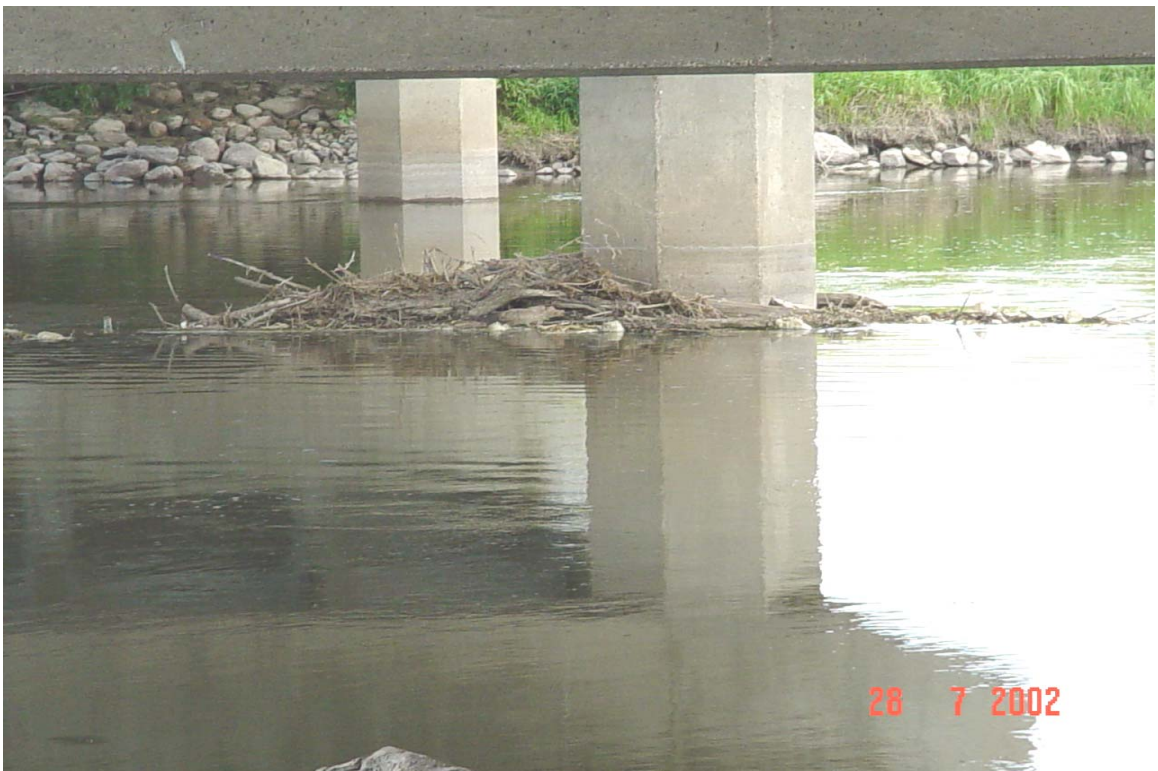
- (E) A heavy accumulation of 1-foot-diameter and smaller timber debris was observed at the downstream column of Pier 2 extending from the channel bottom to 3 feet above the waterline and 5 feet upstream of the column.

Photograph 8. View of Timber Debris at the Downstream Column of Pier 2, Looking East.
